ENGINEERING GEOLOGY

CRESTED BUTTE HIGHLANDS

Section 16, & Portions of Sections 21 & 22  
T. 14 S., R. 85 W.

July, 1973  
Project No. 72-031

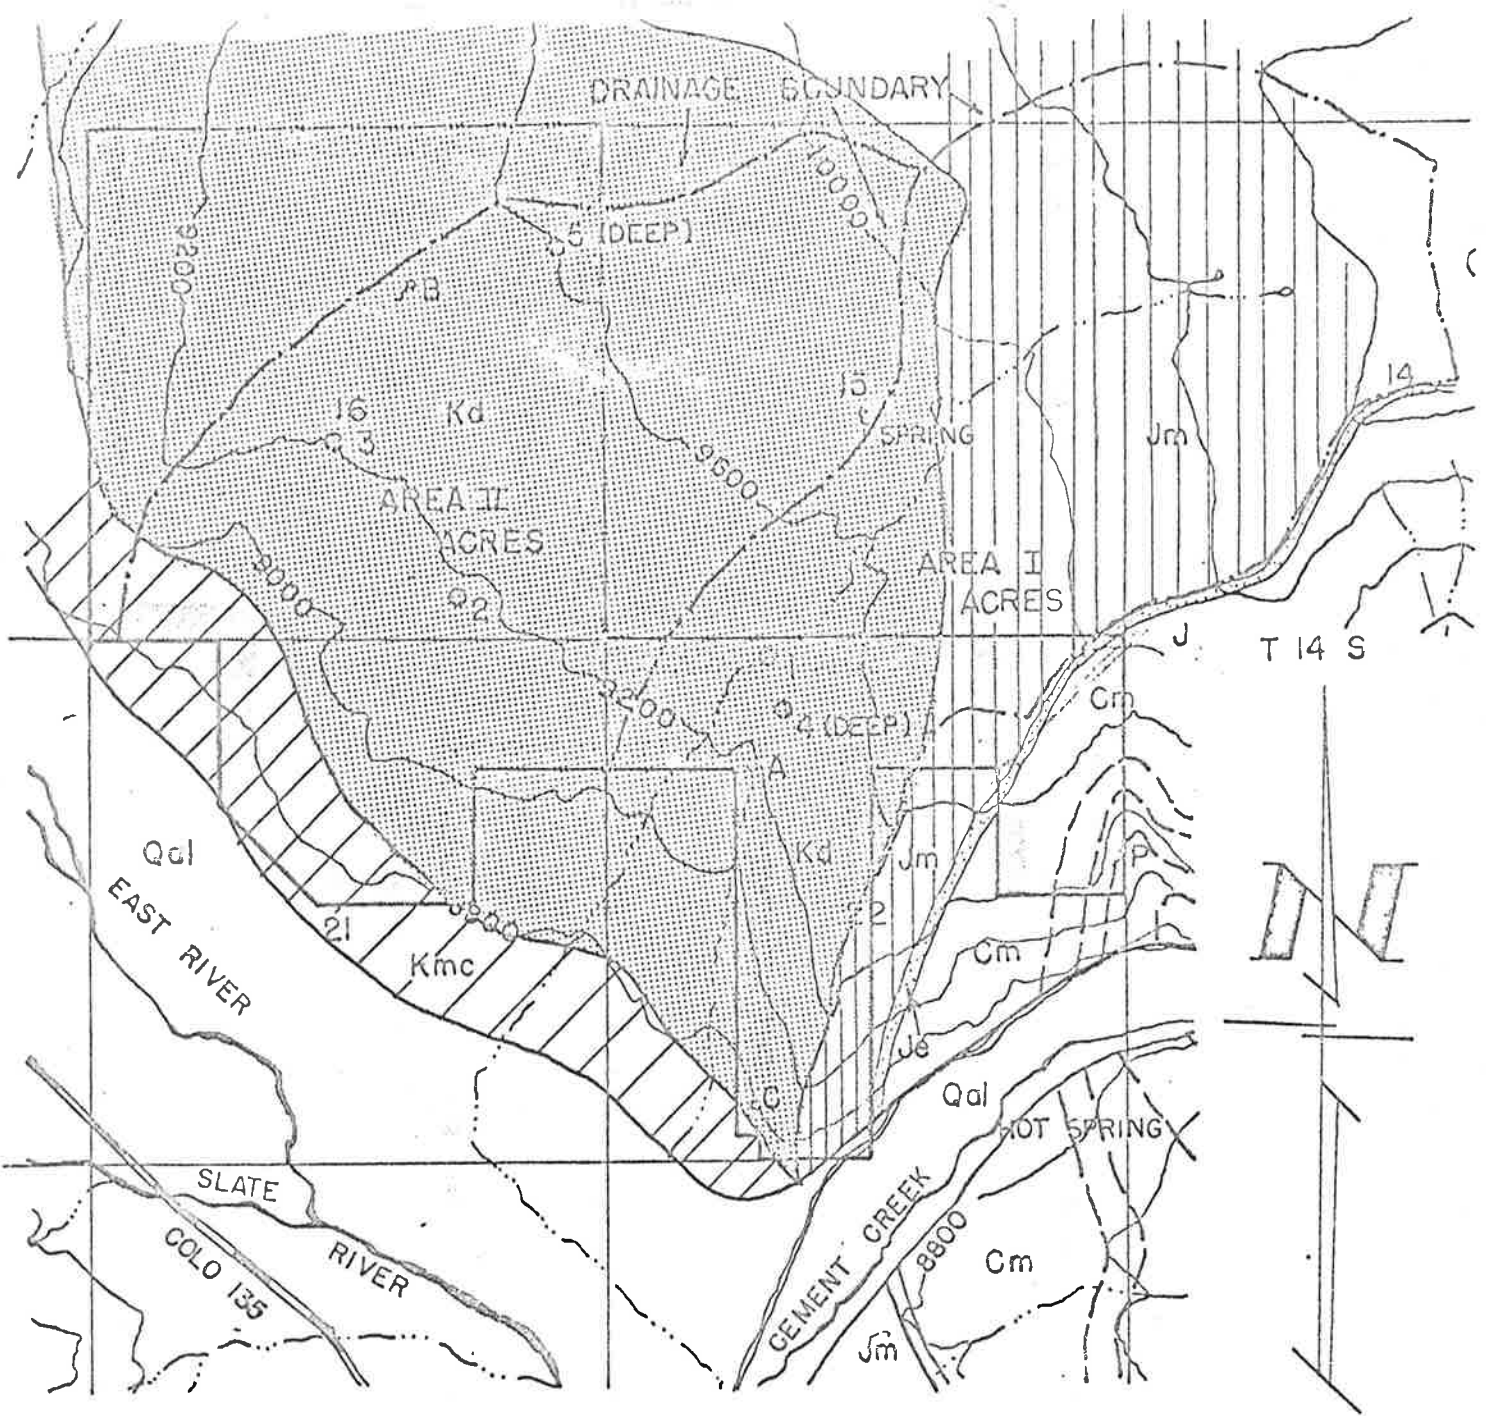
**EXPLANATION**

- Qal ALLUVIUM
-

The results of our investigation and recommendations on the development of the property are given in this report. The study area is shown on the attached geologic map, Plate I.

We recommend the construction of a deep water well through the Dakota and Entrada sandstones at the location designated on Plate I as Well No. 4 (deep). We anticipate that this well can be drilled by a standard rotary, direct circulation drilling rig although it might be necessary to use a cable tool to penetrate the gravelly soil overlying the bedrock. The depth to the bottom of the Dakota and the Entrada sandstones at Well No. 4 (estimated 400 to 600 feet) will provide information on anticipated depths through these aquifers in other portions of the area. If the results of Well No. 4 are favorable, a similar well should be constructed at the location shown on Plate I as Well No. 5 (deep).
